The Fire Performance of Timber-Concrete Composite Floors

A thesis submitted in partial fulfillment of the requirements for the degree of
Master of Engineering in Fire Engineering

Department of Civil and Natural Resources Engineering

University of Canterbury

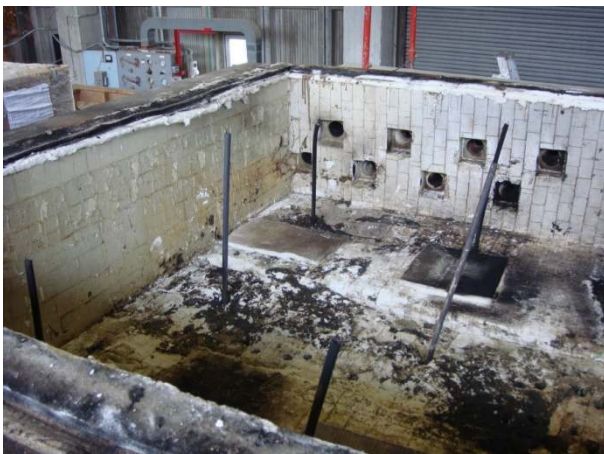
Figure 3.3: Inside the Full Scale Furnace at BRANZ

the furnace to be monitored and controlled (see Figure 3.3 and Figure 3.2). It is lined in ceramic fire bricks and has a number of thermocouples and pressure gauges about the interior to monitor the temperature and pressure, allowing the operator to manage the diesel inflow and produce the desired design fire. The primary use of the furnace is for testing floors and walls, and due to the large 25 tonne crane housed in the warehouse the furnace can easily be picked up and inverted for either use. It can also be used to test structural elements, smoke vents and extraction fans, large doorways or glazed areas. Due to the versatility of the crane, unloaded or loaded tests are possible without any significant risk of damaging the equipment.

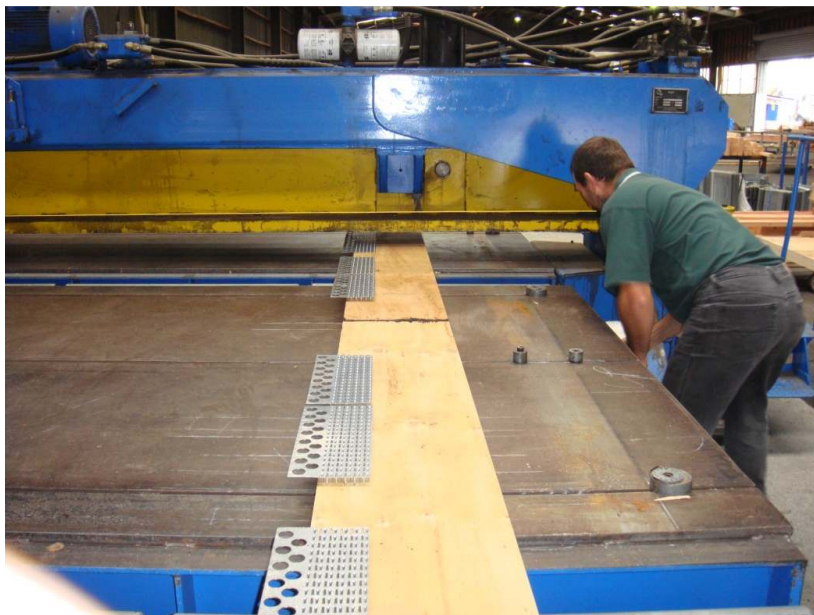
Figure 3.9: Pressing the Steel Plates at Westlake Timber

Two different connection types were used in each test specimen. The first connection type tested was the result of previous short and long term testing by Yeoh (2009) and O'Neill (2007), and was a 50 mm deep by 300 mm long rectangular notch cut into each beam. A 16 mm coach screw was installed 100 mm into the centre of this notch, and concrete was cast about it. Figure 3.8 shows a typical notch connection ready for concrete to be cast into it. The second connection type tested was a toothed steel plate pressed between the double beams. This required a truss press to perform the installation and was carried out at Westlake Timber in Christchurch, shown in Figure 3.9 below.

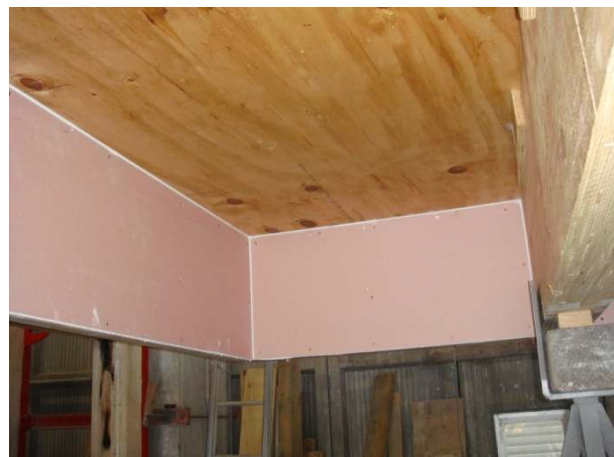
Figure 3.11: Gib Board Lining on the Underside of Test Specimens

backing was nailed to the back of the wall which protruded 82 mm above the top plate of the wall. This allowed for the plywood sheathing of the floor to be nailed down onto the walls about the edges of the specimen, thus leaving 65 mm for the topping concrete to be poured and levelled to at a later date. The inside of the walls were lined with two layers of 13 mm Winstones Fyrelite Gib Board (a fire rated gypsum plasterboard product) which would conservatively achieve a minimum of 60 minutes fire protection. These were installed in a staggered fashion with overlapping joints, fastened at 200 mm centres with approved screws and stopped with an intumescent filler along the joints, which can be seen in Figure 3.11.

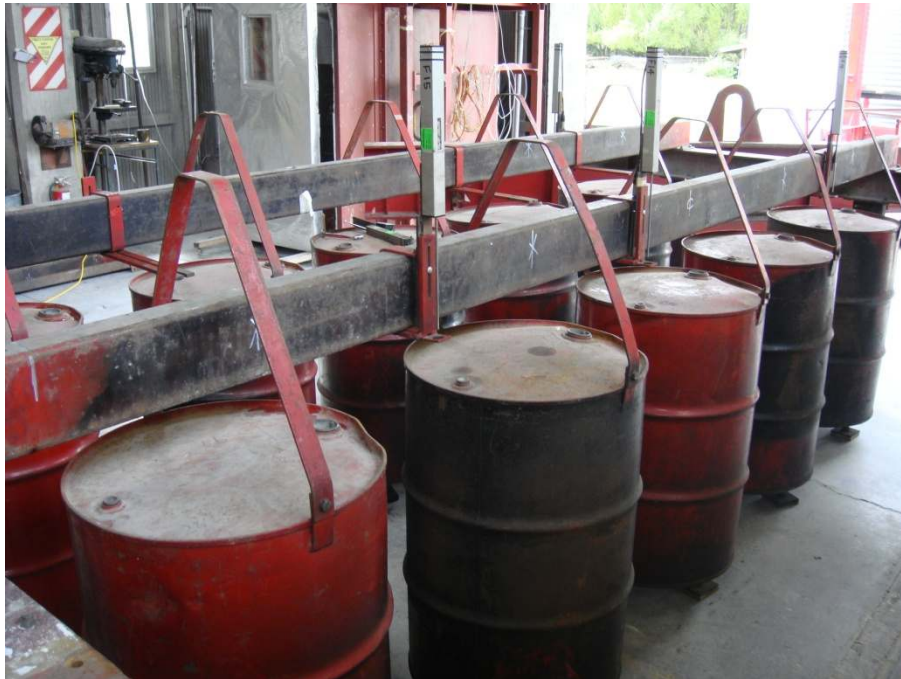
Figure 3.15: The Loading Rig

beams with 5 barrels along each beam, and the barrels had three feet to spread the load over the slab area. This was ideal for the floor testing as each line of barrels corresponded to the centreline of the beams to be loaded. The barrels could be filled with water and steel weights could be added to the top of the barrels to obtain loads up to approximately 3 kPa. Each barrel had a steel hanger which allowed them to load a floor until its vertical displacement was such that the hanger would catch on the rig beam and support the weight of the barrels. This prevented the barrels from falling into the furnace upon failure of a loaded test. Figure 3.15 shows the loading rig before the first test.

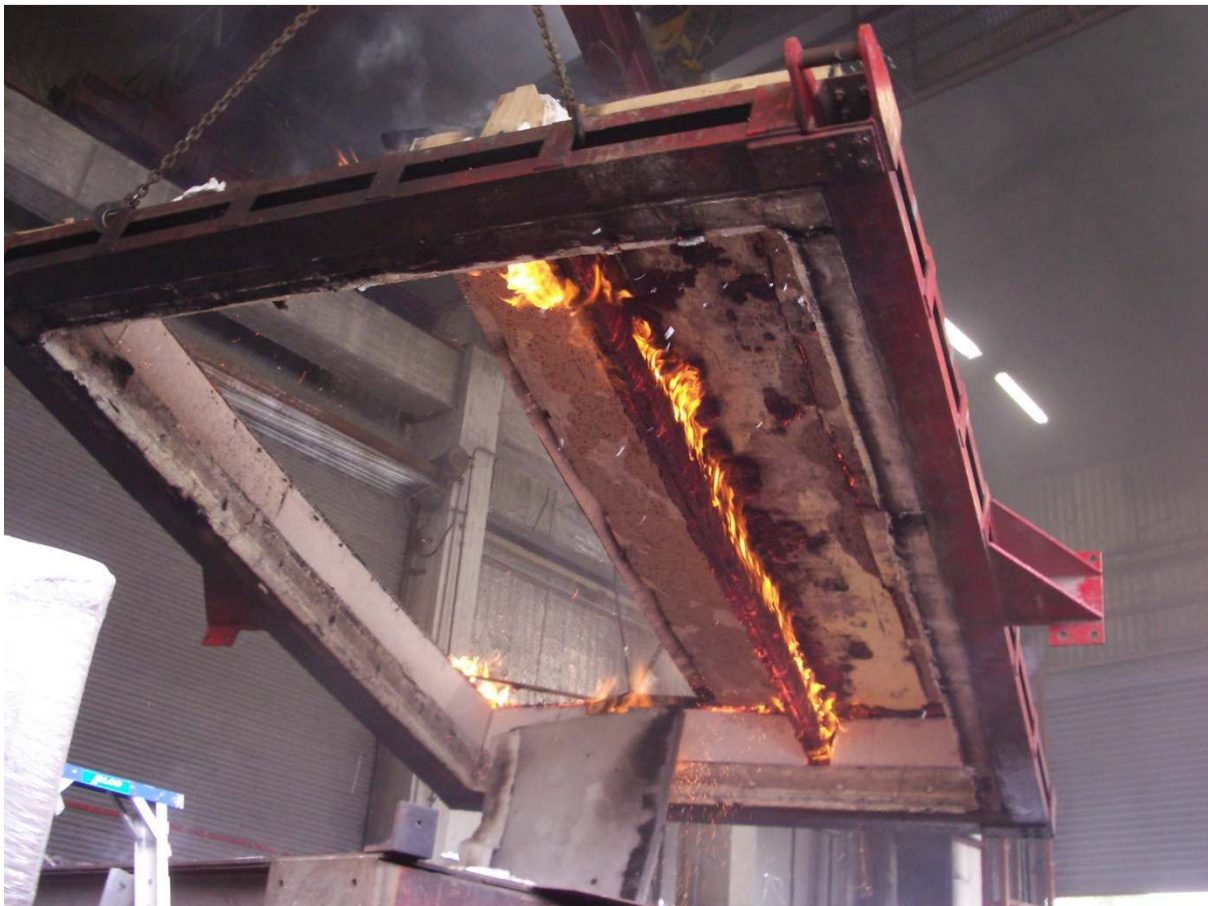
Figure 4.1: The Underside of the Failed 300 mm Beam Floor

The first floor specimen tested on the 7th April 2009 was the smaller 300 mm beam floor, which was tested to destruction. This lasted approximately 75 minutes under the ISO 834 design fire and 1.56 kPa applied load. The side with notched connections was the first to fail, and the testing was terminated immediately at this point due to a large amount of flames spewing out of the furnace and the loss of control of the test conditions. Fortunately the damage to the furnace interior was mainly superficial, and due to the fire bricks requiring renewal the damage was easily repaired for testing the next day as new materials were on hand. After enough cross section was lost in the timber beams the concrete slab could not support the loads transferred to it, resulting in catastrophic failure. Visible in Figure 4.1 is the spalling damage to the underside of the concrete, the extent of the char damage to the beams and some charred plywood remains.

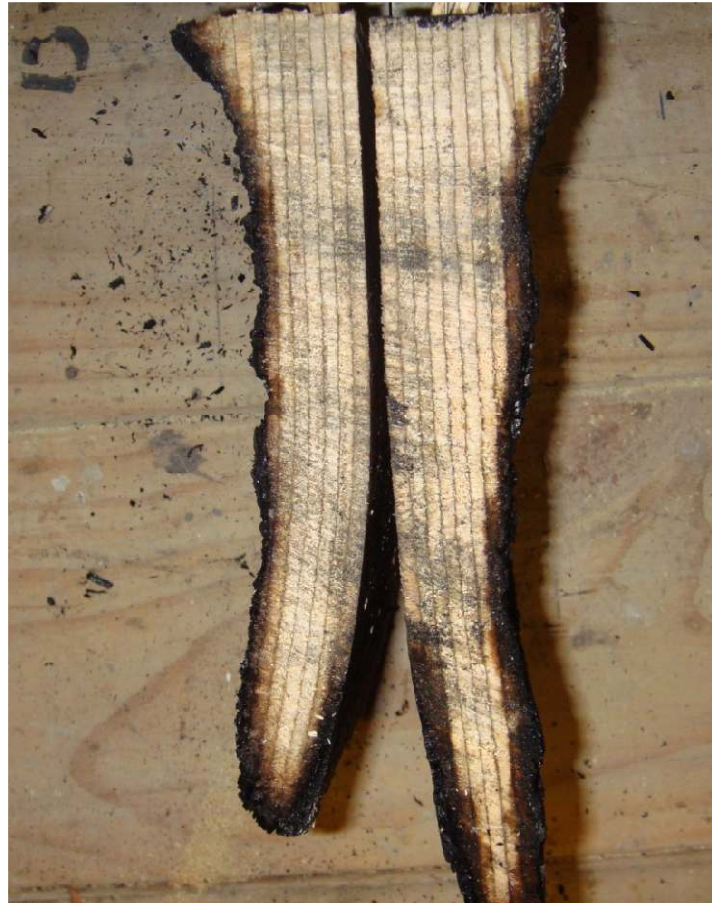
**Figure 4.9: Residual Section of the 400 mm Floor
After 60 minutes Exposure**

The section shown in Figure 4.9 was removed at one of the notched connections. The centre of the furnace was located to the left of the beams shown here, hence the greater fire damage on this side can be seen from the figure. The average opening size was 25 mm at the bottom of the beams, measured from the tip of the shorter beam as seen on the left of the Figure. Directly above this cross section shown is the timber-concrete interface at the notch, the timber is jagged and uneven here due to the sample being pried loose from the concrete, it is not damage from the fire.

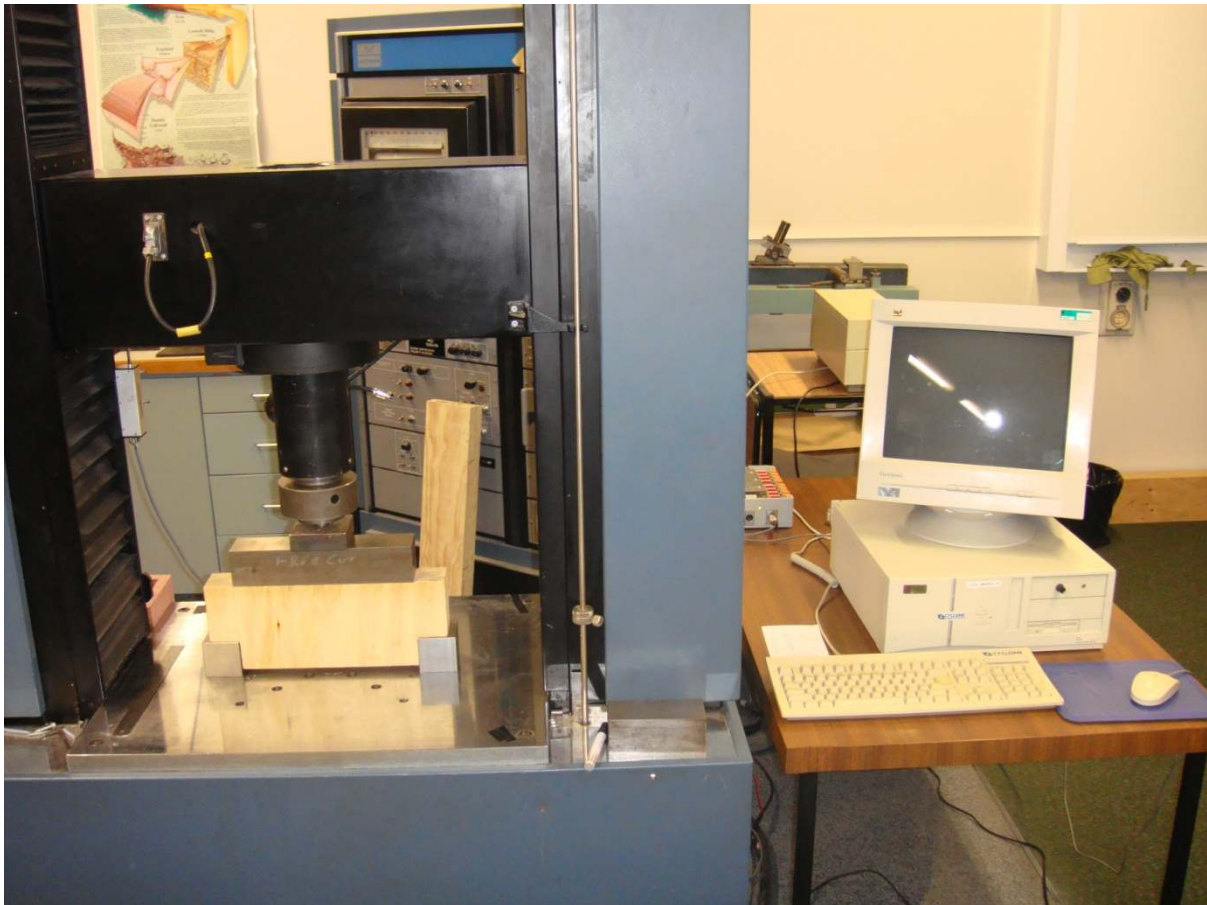
Figure 5.2: The Instron Testing Apparatus and Datalogging Equipment

An Instron test frame was used to apply the loads required and ensure a stable testing assembly for the duration of the testing. The Instron could apply up to 250 kN of force onto a specimen situated on the level testing surface. Due to the previous intended use for the machine, the fixed loading rates increased in increments of 0.5 mm/minute although the calculated loading rates for compression and shearing tests were 0.75 and 0.60 mm/minute respectively (ASTM D 143-94, 2007). As per the requirements of the standard, the loading head was equipped with a spherical bearing to allow uniform distribution of load across the timber surface. The test apparatus with a shear specimen in place is shown in Figure 5.2.

As seen in Figure 5.2, steel blocks were used as supports and spreaders across the shear test specimens. Small nails were implanted into the compression specimens at a gauge length of 200 mm and potentiometers attached to measure the displacement during testing and output a load-slip curve, allowing the stiffness of the specimens to be calculated. Although the Instron had a potentiometer on the ram, the results recorded from this potentiometer were not used as the timber specimens exhibited a slight amount of crushing as the load was initially applied, hence skewing the displacement readings from the ram potentiometer. The potentiometer setup for the compression testing is shown in Figure 5.3.

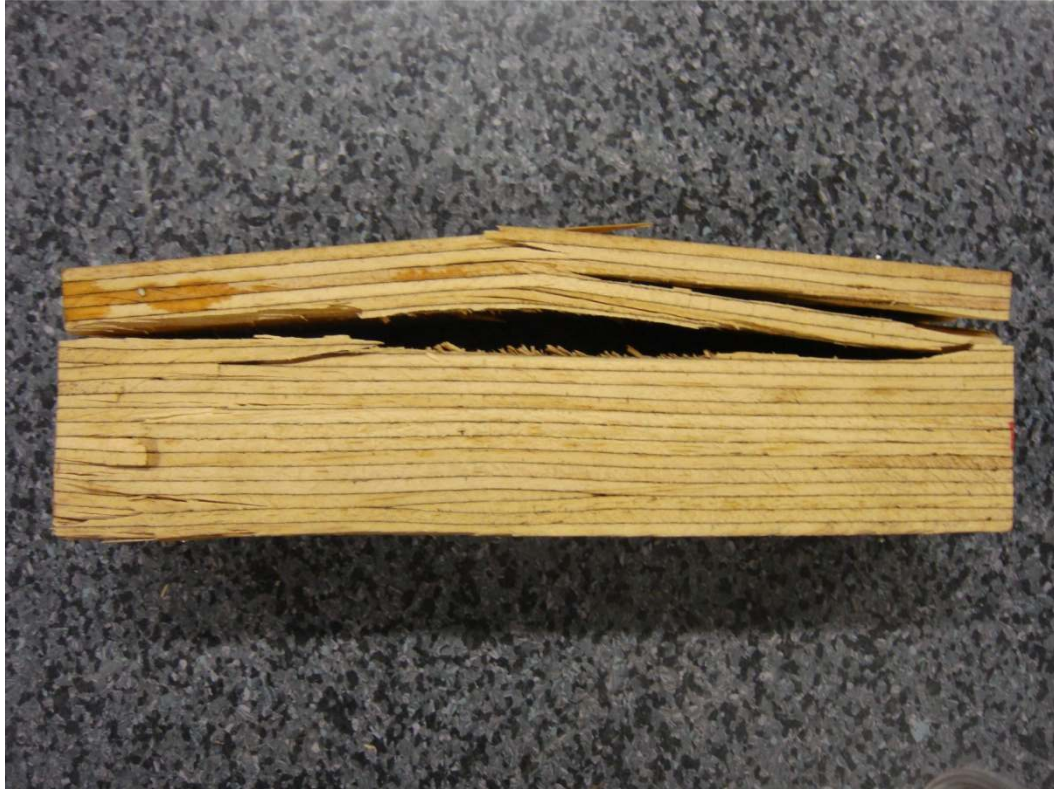
Figure 5.7: Compression Specimen Tested at 50 °C (Pre-dried)

The pre-dried specimens and specimens heated over 100 °C exhibited extremely brittle failure behaviour, as the absence of any moisture ensured the failure mode be dictated by the propagation of a crack through the specimen, as seen in Figure 5.7. The fracture plane passed through a veneer, and was not down a glue line.
